FACILITY COMPLIANCE INSPECTION REPORT

Division of Waste Management Solid Waste Section

Date of Site Inspection: August 18, 2011 **Date of Last Inspection:** October 26, 2010

Fogleman & Fogleman Soils, Inc. LCID Landfill
 4005 Intermere Road
 Durham, NC 27704

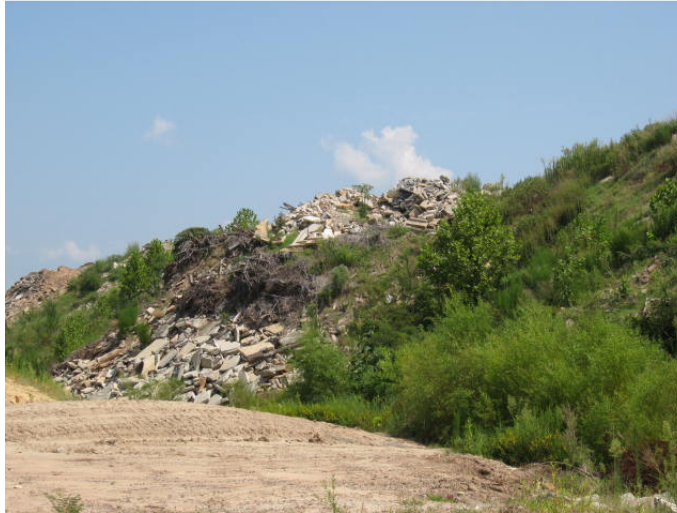
17. The facility stockpiles concrete to be crushed. Much of the concrete on site has been covered with soil to crush at a later date.
18. The facility provides segregated loads of LCD to the general public for firewood. Jay Fogleman was asked to ensure that the firewood storage area is not located adjacent to the working face and that the LCD designated for firewood is routinely removed from the site.

Stockpiled concrete, west of LCID fill area

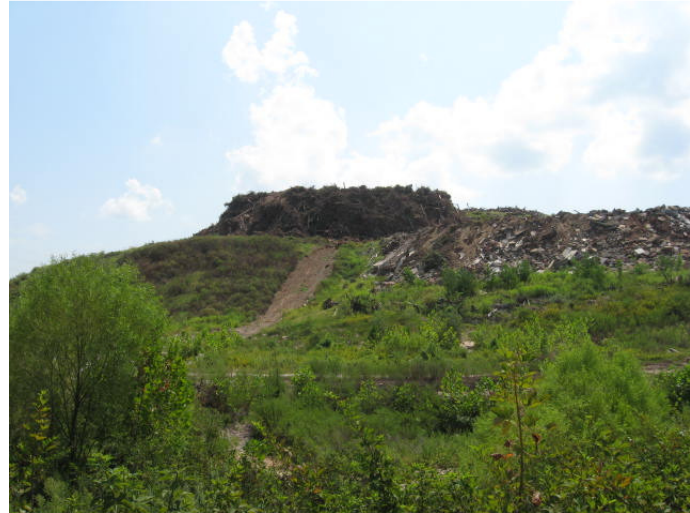
Left side of working face

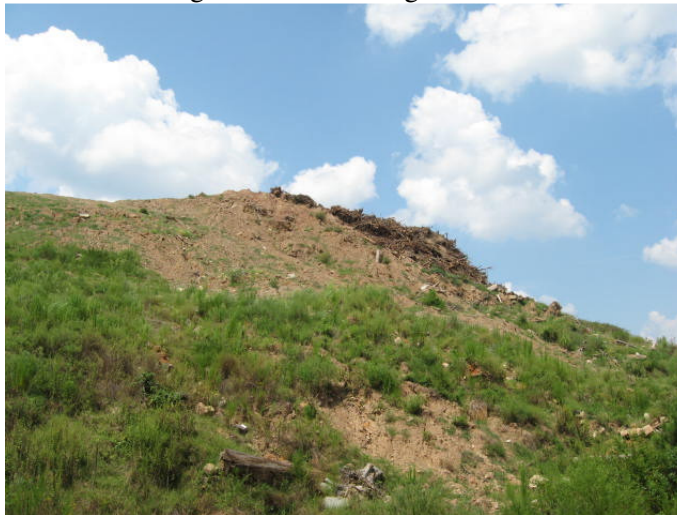
Right side of working face

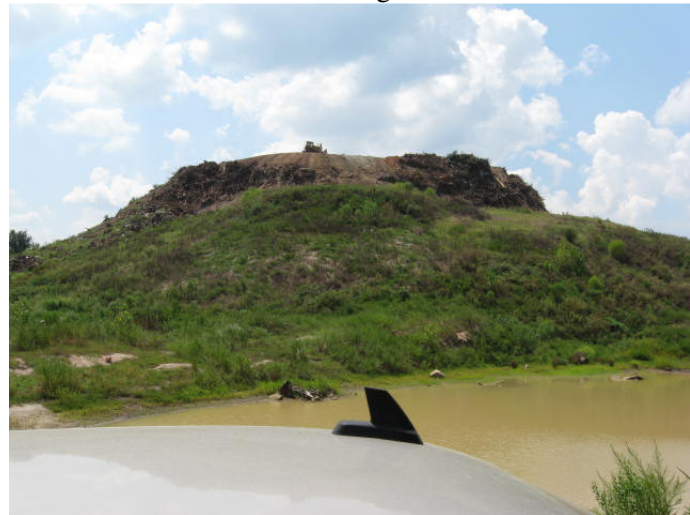
Rear of working face

13. Ensure that the section of side slope on the north-east side of the landfill is repaired.
14. Ensure that land clearing debris (LCD) that rolled down the rear of the north-east side slope is removed or covered with soil.
